SOUTH FORK CLEARWATER RIVER HABITAT ENHANCEMENT
NEZ PERCE NATIONAL FOREST

Project Number 84-5
Contract Number **DE-AI79-84BP16475**

April, 1992

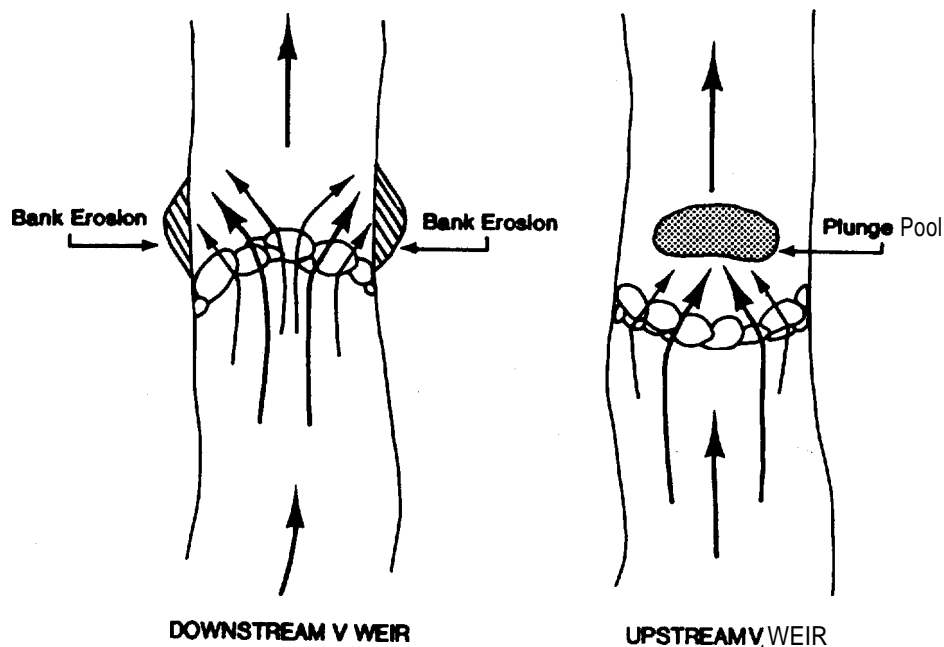
In several cases, structures created pools as planned, but the pools are shallow and lacking in cover, and therefore of negligible benefit to fish. Although state-of-the-art technology at the time, log weirs that increase stream width:depth ratios, and create large, shallow pools, are now known to be of questionable value. In general, more emphasis should have been placed on pool **quality** than pool quantity, and more attention should have been paid to reducing width:depth ratios.

Figure 11. Comparison of hydraulic action on a downstream and an upstream boulder weir, showing erosion potential (downstream v) and pool formation (upstream V).

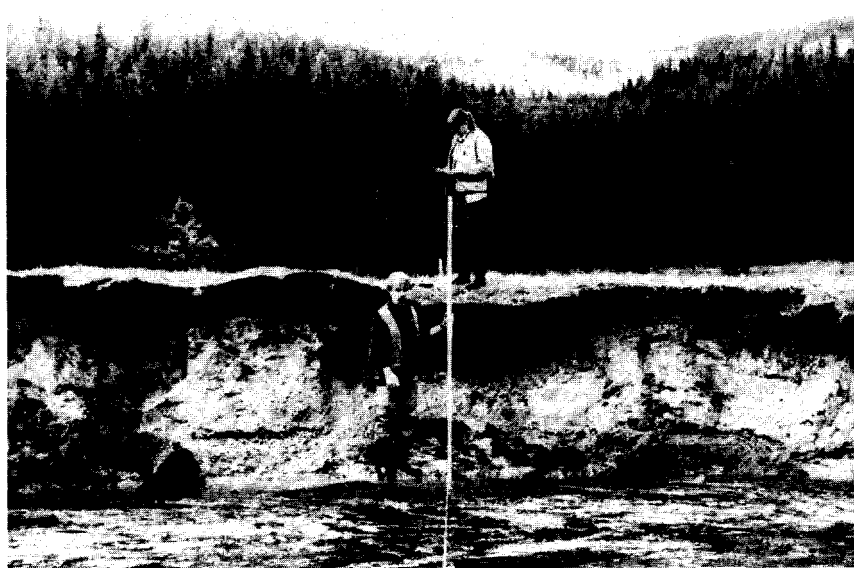
Reach I, in Upper Red River, flows mostly through privately owned meadows, although a small portion of it lies on Forest land. In upper portions of Reach I, where the riparian area has not been grazed by stock, the channel is relatively narrow and deep (a C6 channel type [Rosgen, 1985]), and overhanging banks are prevalent. With the exception of its sediment load, this upstream portion of the reach appears to be in near-pristine condition. Lower parts of the reach, however, especially the private lands, had been heavily grazed and were subject to severe bank erosion (Figure 20) (A conversion from a C6 to a C3 channel type had occurred [see Rosgen, 1985].) In fact, up to 200 tons of sediment were once estimated to erode annually from banks along one portion of Reach I. Problems identified for Reach I in the January 1984 amendment to the USFS/BPA agreement were eroding banks, lack of overhanging vegetation, and lack of shade.

Figure 20. Eroding banks, Reach I, Red River.

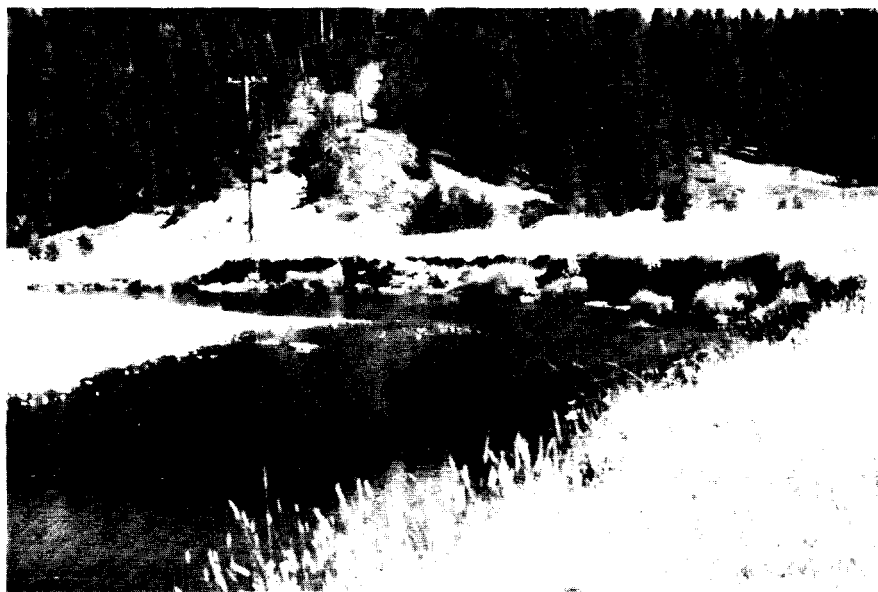
At two sites, the rip rapping stabilized the banks as intended, and is now also providing instream cover (Figures 25 and 26). In one stretch of Reach V, however, individual or clustered boulders were not embedded deeply enough on the outsides of meander bends; bank erosion has left boulders isolated by bank retreat.

Figure 25. Unstable bank in Reach V, Red River, before bank stabilization in 1984.

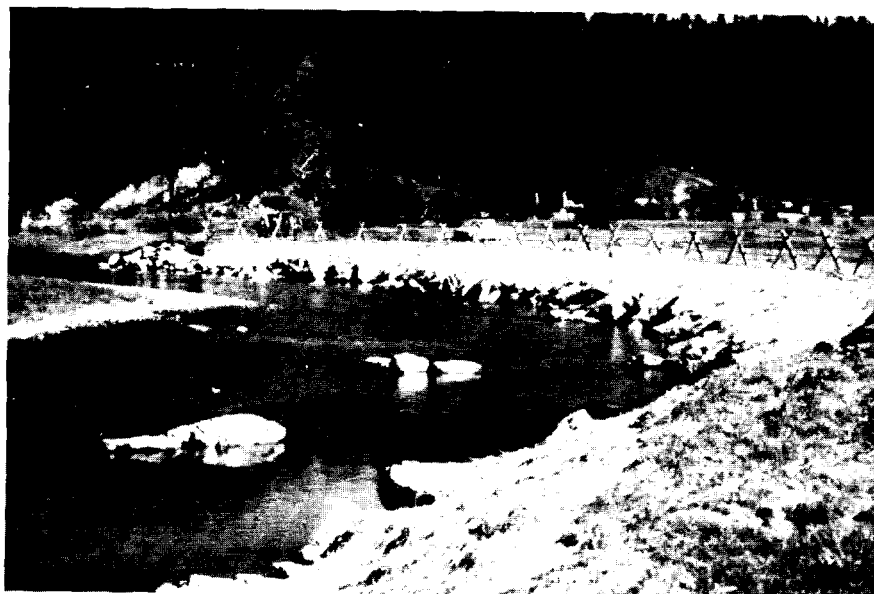
Figure 26. Same section of bank in Reach V. after bank stabilization in 1984.

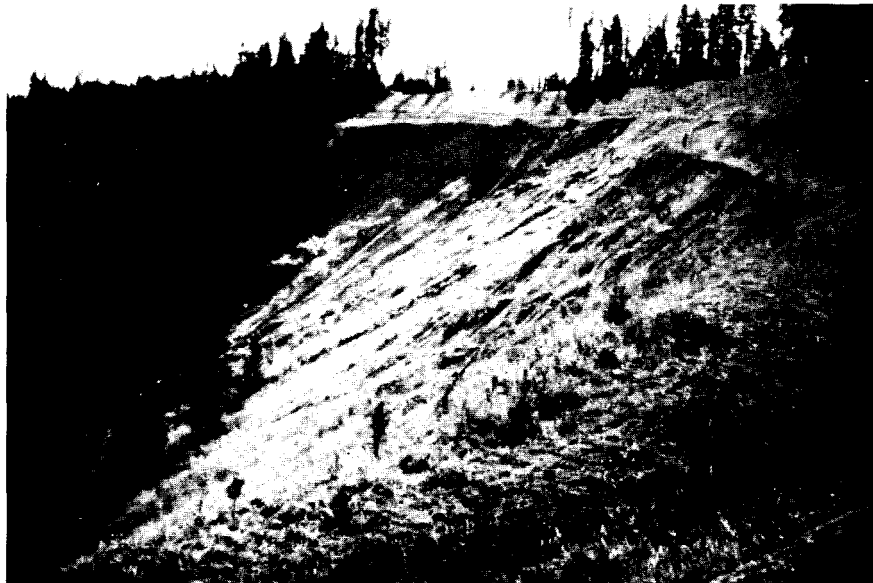
Figure 37. Upper slopes of Haysfork Gloryhole, 1988. Note bench in upper pit, and newly planted lodgepole pine above bench. Also note failure of fill material in picture center.

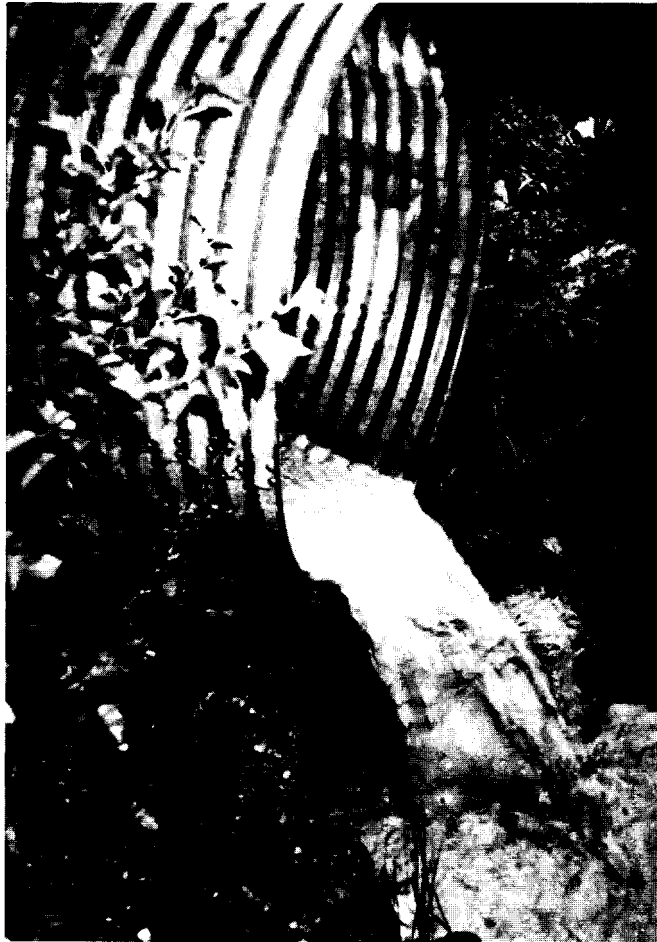
Figure 41. Culvert under County Road 222 draining sediment-laden runoff from Cal-Idaho Gloryhole. 1987.

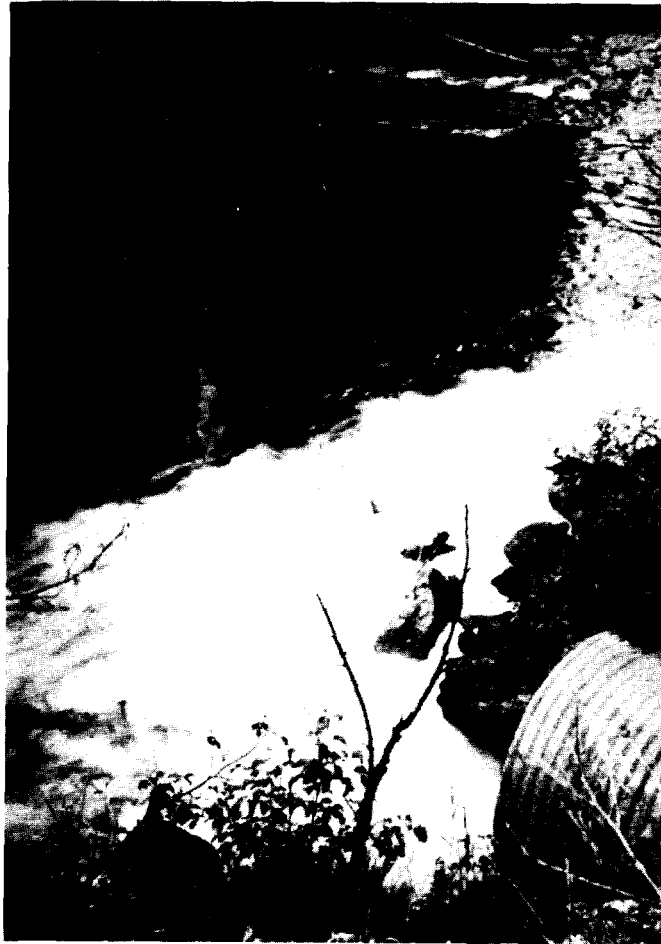
Figure 42. Culvert emptying sediment-laden runoff from the Cal-Idaho Gnotyhole into Red River, 1987. The distinct line in the center of the picture is where the muddy runoff meets the clear water in Red River.
